The Road Inventory of Sutter River National Wildlife Refuge Yuba City, CA

Prepared By:
Federal Highway Administration
Central Federal Lands Highway Division
May 2012

Sutter National Wildlife Refuge - 81623

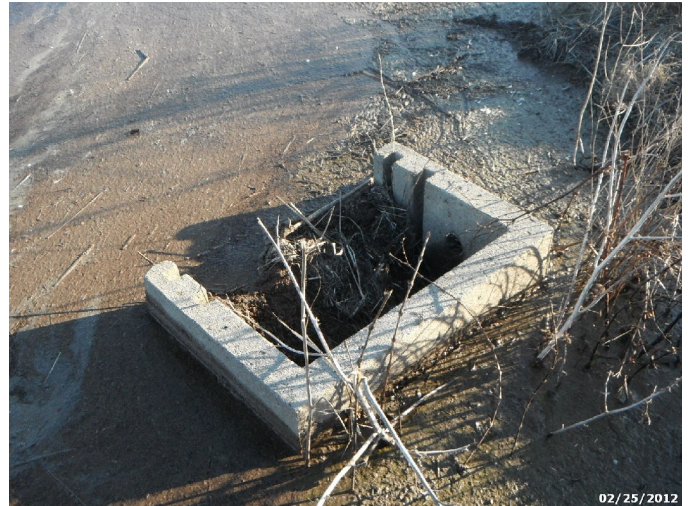
Photo: SUTT_C4_1281 Route: 400-001-0.11
Plastic WCS Flashboard Riser 30ft long 24in dia. 3ft deep
Asset# NA

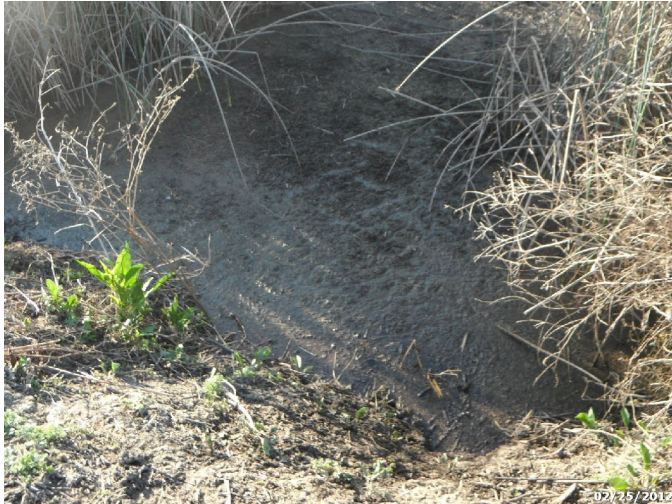
Photo: SUTT_C4_1282 Route: 400-001-0.11
Plastic WCS Flashboard Riser 30ft long 24in dia. 3ft deep
Asset# NA

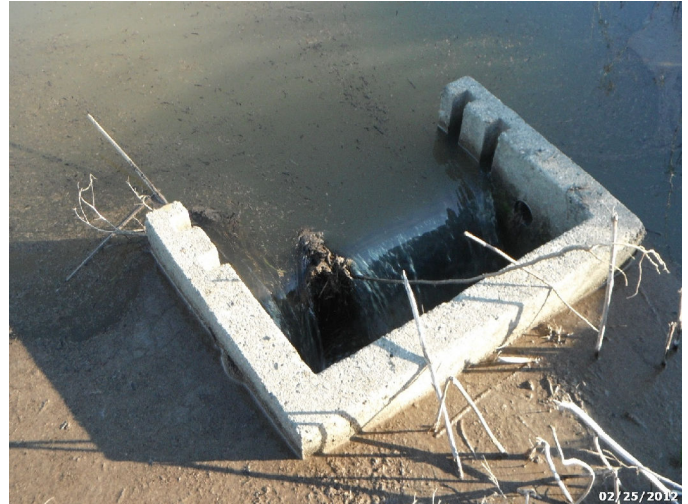
Photo: SUTT_C4_1283 Route: 400-001-0.47
Plastic WCS Flashboard Riser 25ft long 24in dia. 2ft deep
Asset# NA

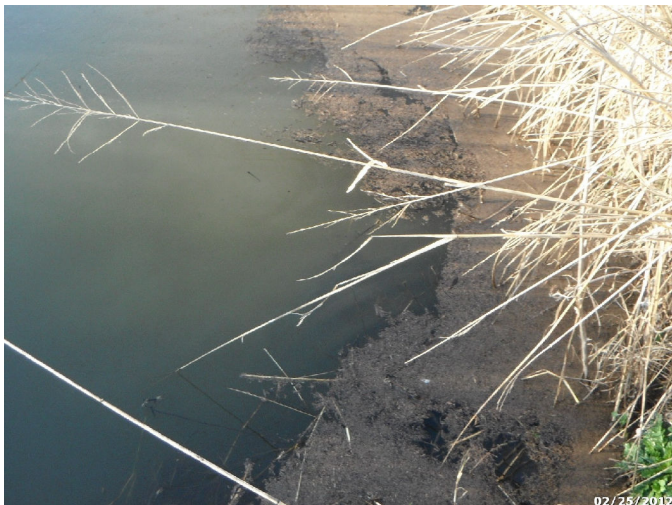
Photo: SUTT_C4_1284 Route: 400-001-0.47
Plastic WCS Flashboard Riser 25ft long 24in dia. 2ft deep
Asset# NA

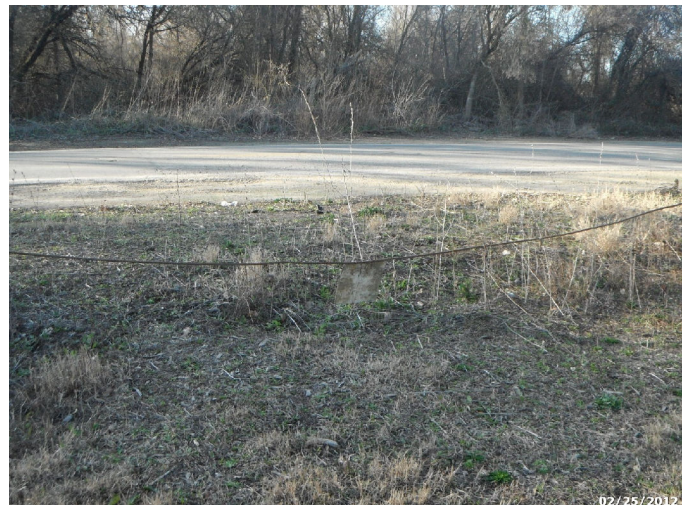
Photo: SUTT_C4_1285 Route: 400-001-0.56
Metal Cable Gate
Asset# 10059352

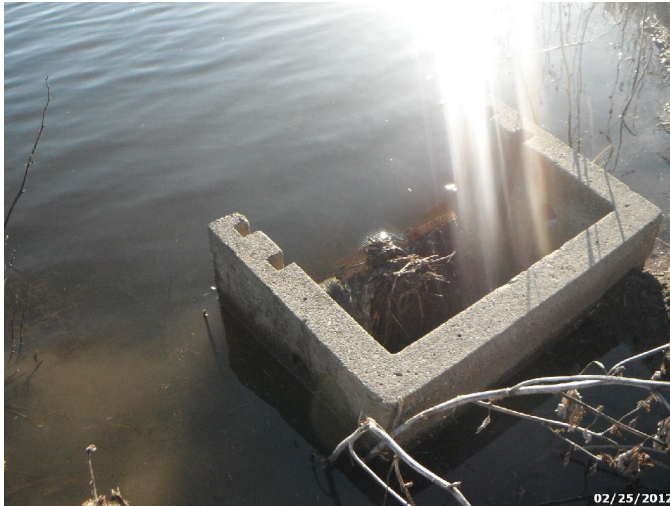
Photo: SUTT_C4_1286 Route: 400-001-0.76
Plastic WCS Flashboard Riser 30ft long 24in dia. 2ft deep
Asset# NA

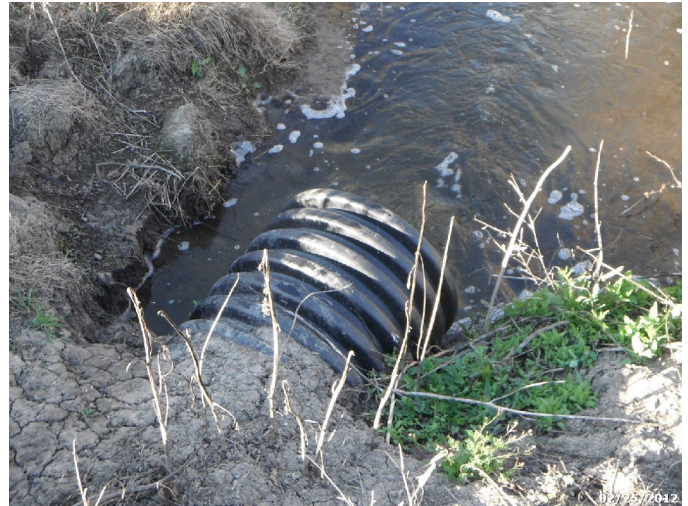
Photo: SUTT_C4_1287 Route: 400-001-0.76
Plastic WCS Flashboard Riser 30ft long 24in dia. 2ft deep
Asset# NA

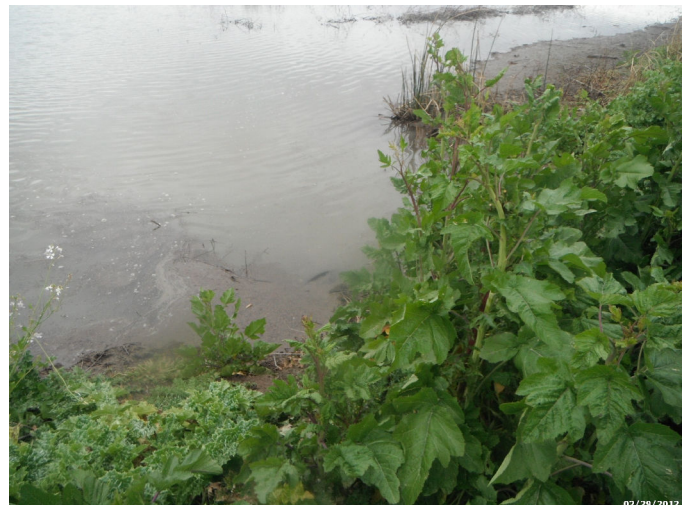
Photo: SUTT_C4_1861 Route: 412-002-0.59
Plastic WCS Flashboard Riser 30ft long 24in dia. 1ft deep
No Inlet photo available
Asset# NA 8-034

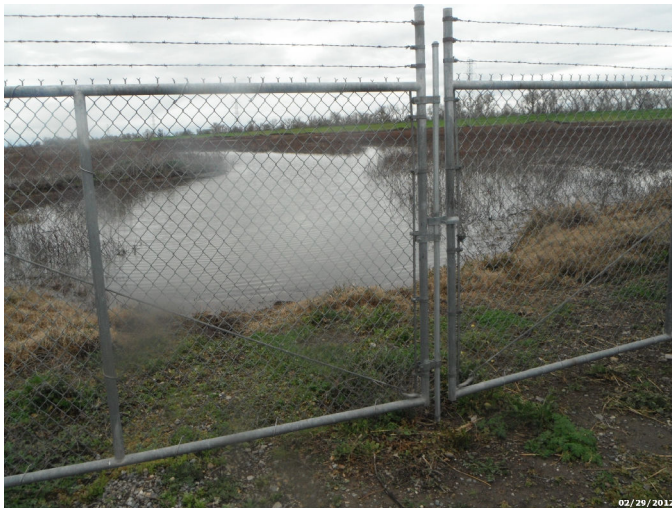
Photo: SUTT_C4_1864 Route: 800
Metal Chain Link Gate
Asset# 10000537

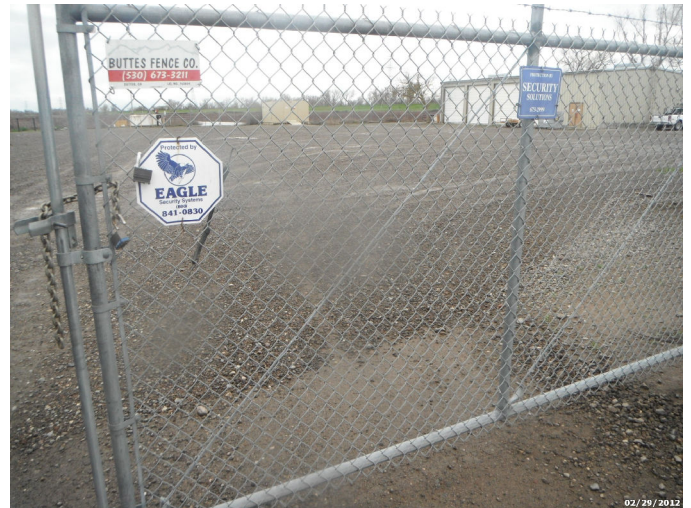
Photo: SUTT_C4_1865 Route: 800
Metal Chain Link Gate
Asset# 10000537

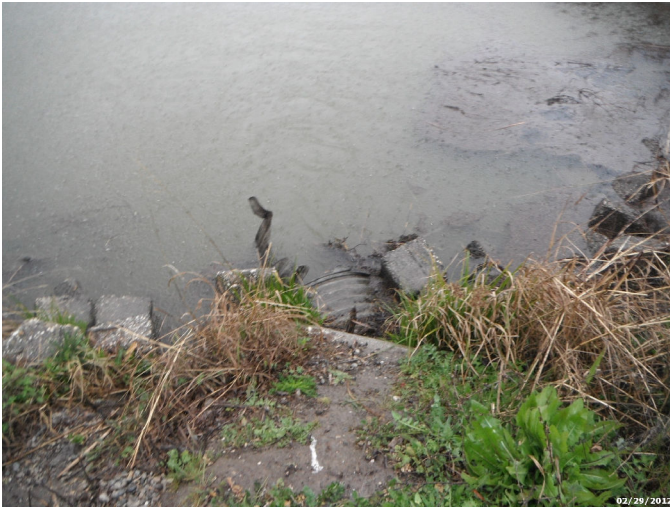
Photo: SUTT_C4_1785 Route: 901
Metal Culvert 40ft long 36in dia. 2ft deep
Asset# NA

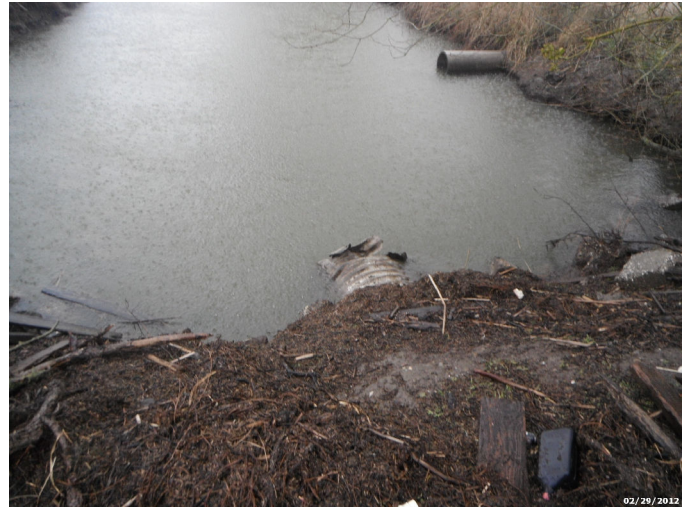
Photo: SUTT_C4_1786 Route: 901
Metal Culvert 40ft long 36in dia. 2ft deep
Asset# NA

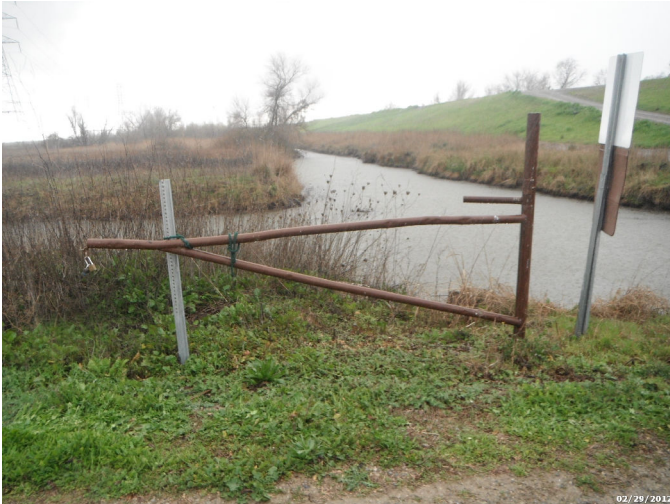
Photo: SUTT_C4_1784 Route: 901
Metal Open Rail Gate
Asset# 10059352
